# MARINE CASUALTY REPORT

SS MARINE ELECTRIC,  
O.N. 245675,

CAPSIZING AND SINKING  
IN THE ATLANTIC OCEAN  
ON 12 FEBRUARY 1983  
WITH MULTIPLE LOSS OF LIFE

REPORT NO. 16732/0001 HQS 83

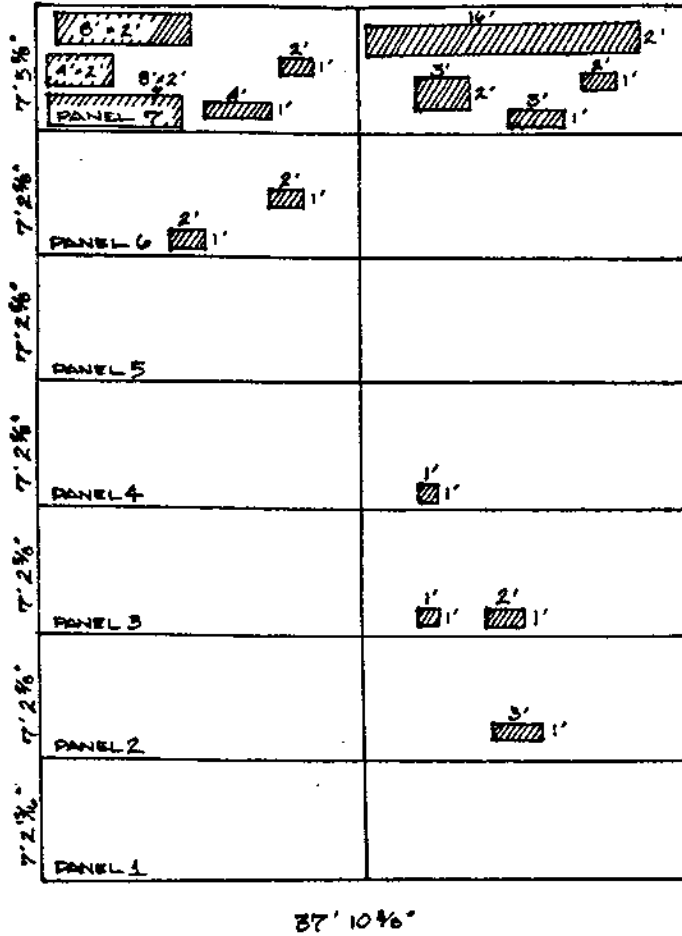
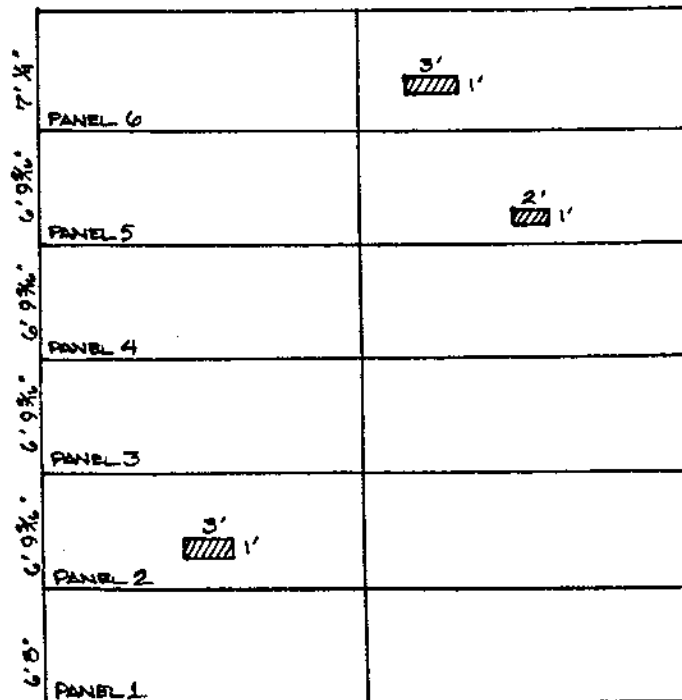
Hatch Cover Areas  
needing repairs, as  
identified on sketches  
by Chief Mate, from  
Exhibit 20

292. The hatch cover sketches, Exhibit 20, showed that three of six panels for No. 1 hold had areas that were deteriorated, and wasted, and that five of seven panels on No. 2 hold had wasted and holed areas. The exact locations of the deteriorated areas

within each panel were not clear from the sketches, but the dimensions of each area were described in feet. The preceding figure shows a scale drawing of each panel, for holds Nos. 1 and 2, with the areas which the Chief Mate identified shaded in. It should be noted that guaguings were not taken on any of these covers.

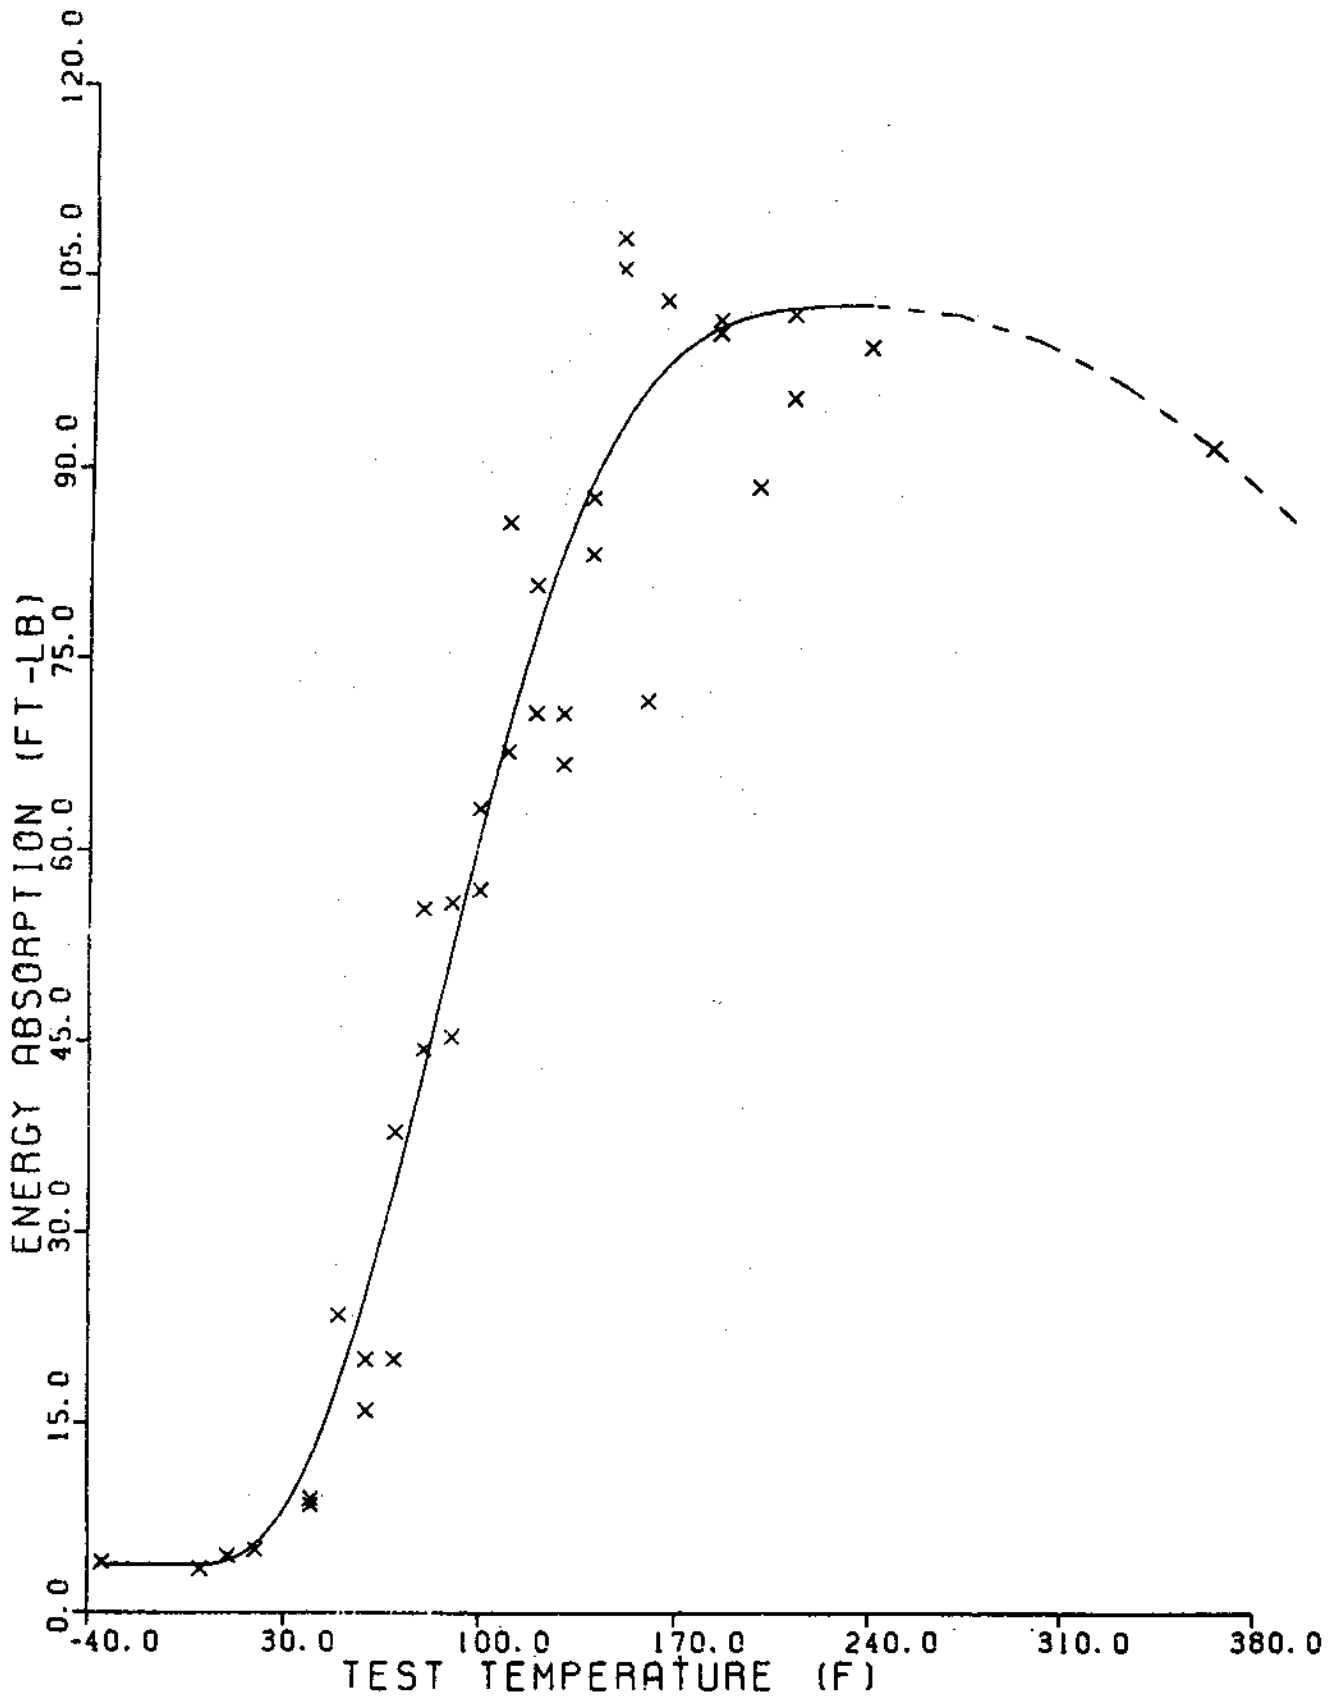
Charpy V-Notch Transition Curve

446. An additional study of the steel samples was made by EMTEC Corporation, of Norman, Oklahoma, in the area of Crack Tip Opening Displacement (CTOD) testing. This criteria attempts to define the minimum crack size that the steel could sustain at a specified stress level and temperature before brittle fracture occurs. Two samples were made - one in the starboard B strake, and the other from the starboard A strake. The testing revealed that the critical crack size was 2.5 inches for dynamic loading, and 40 inches for slow loading at 40 degrees Fahrenheit, and a stress of 20,000 psi. The metallurgists who prepared this report stated the actual loading on the MARINE ELECTRIC probably fell somewhere between the dynamic and static loading cases. They also noted that the appearance of the metal samples examined showed the metal had exhibited good ductile behavior when the hull broke apart.
