MARINE ACCIDENT REPORT

**CAPSIZING AND SINKING OF THE
U.S. MOBILE OFFSHORE DRILLING
UNIT OCEAN RANGER OFF THE
EAST COAST OF CANADA
166 NAUTICAL MILES EAST OF
ST. JOHN'S, NEWFOUNDLAND
FEBRUARY 15, 1982**

NTSB-MAR-83-2

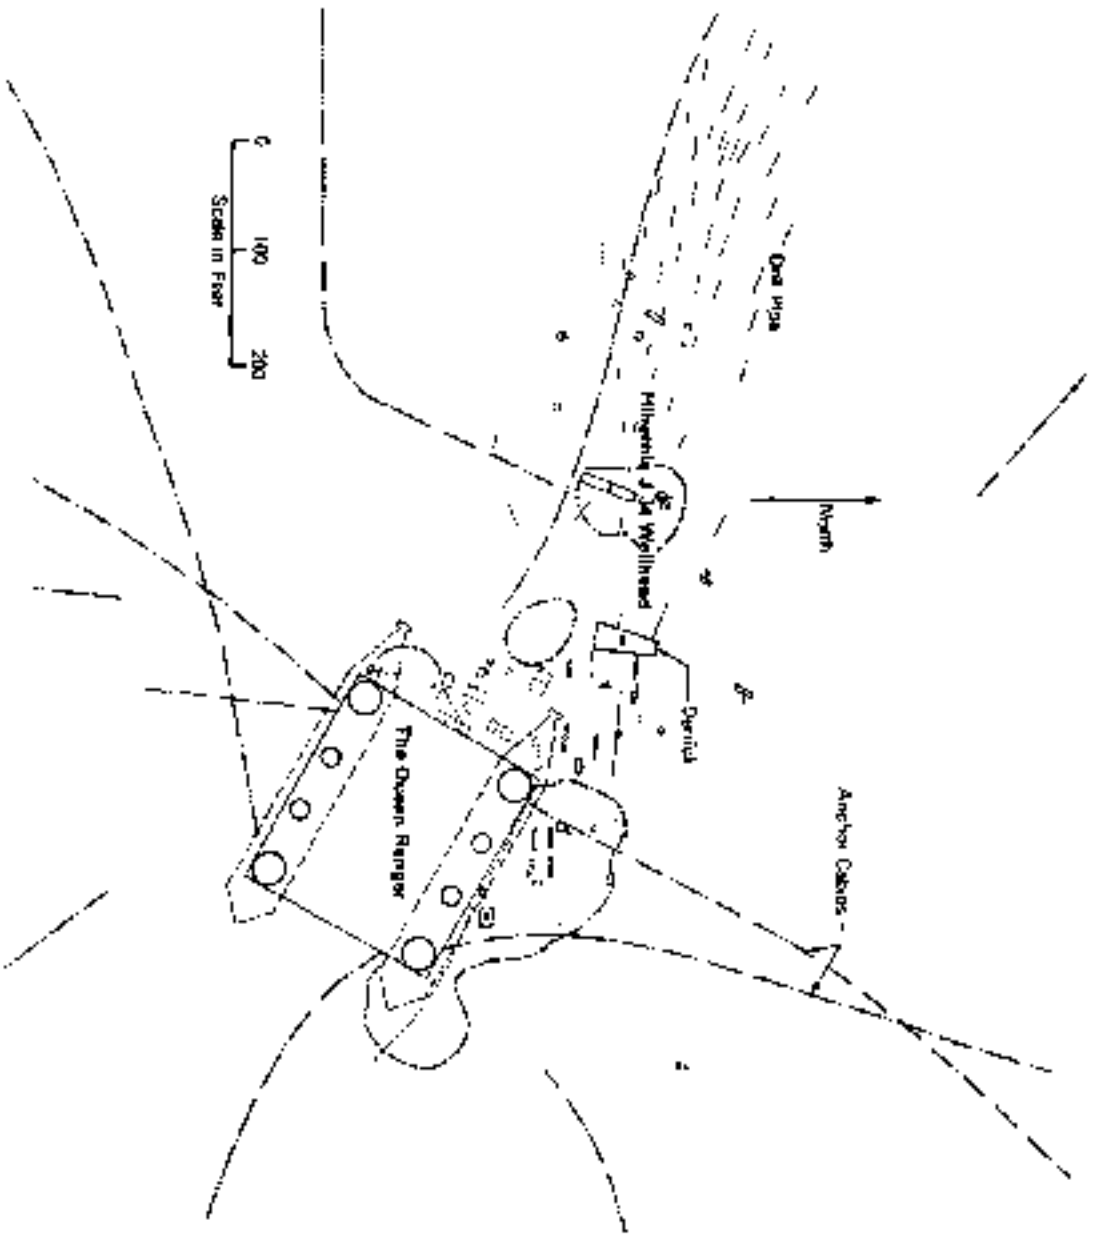
Figure 6.--March 8, 1982, side scan sonar survey of the OCEAN RANGER.

The OCEAN RANGER sank upside down, with its bow on a heading of 117° in about 260 feet of water about 150 yards southeast from its anchored position over the wellhead and is resting on the bottom. Underwater videotapes of the sunken drilling unit were taken in early March 1982 by an unmanned submersible. The videotapes showed minor damage to the bows of both lower hulls, two broken portlights in the control room, and that all four deadlights were closed. The videotapes did not show any other major structural damage to the OCEAN RANGER's columns or lower hulls. A side scan sonar survey, conducted between February 18 and March 2 1982, located drill pipe and other debris scattered up to 300 yards from the sunken drilling unit in a northwest to southeast direction. The value of the drilling unit was estimated at \$125 million.
