MARINE ACCIDENT REPORT

**CAPSIZING AND SINKING OF THE
U.S. MOBILE OFFSHORE DRILLING
UNIT OCEAN RANGER OFF THE
EAST COAST OF CANADA
166 NAUTICAL MILES EAST OF
ST. JOHN'S, NEWFOUNDLAND
FEBRUARY 15, 1982**

NTSB-MAR-83-2

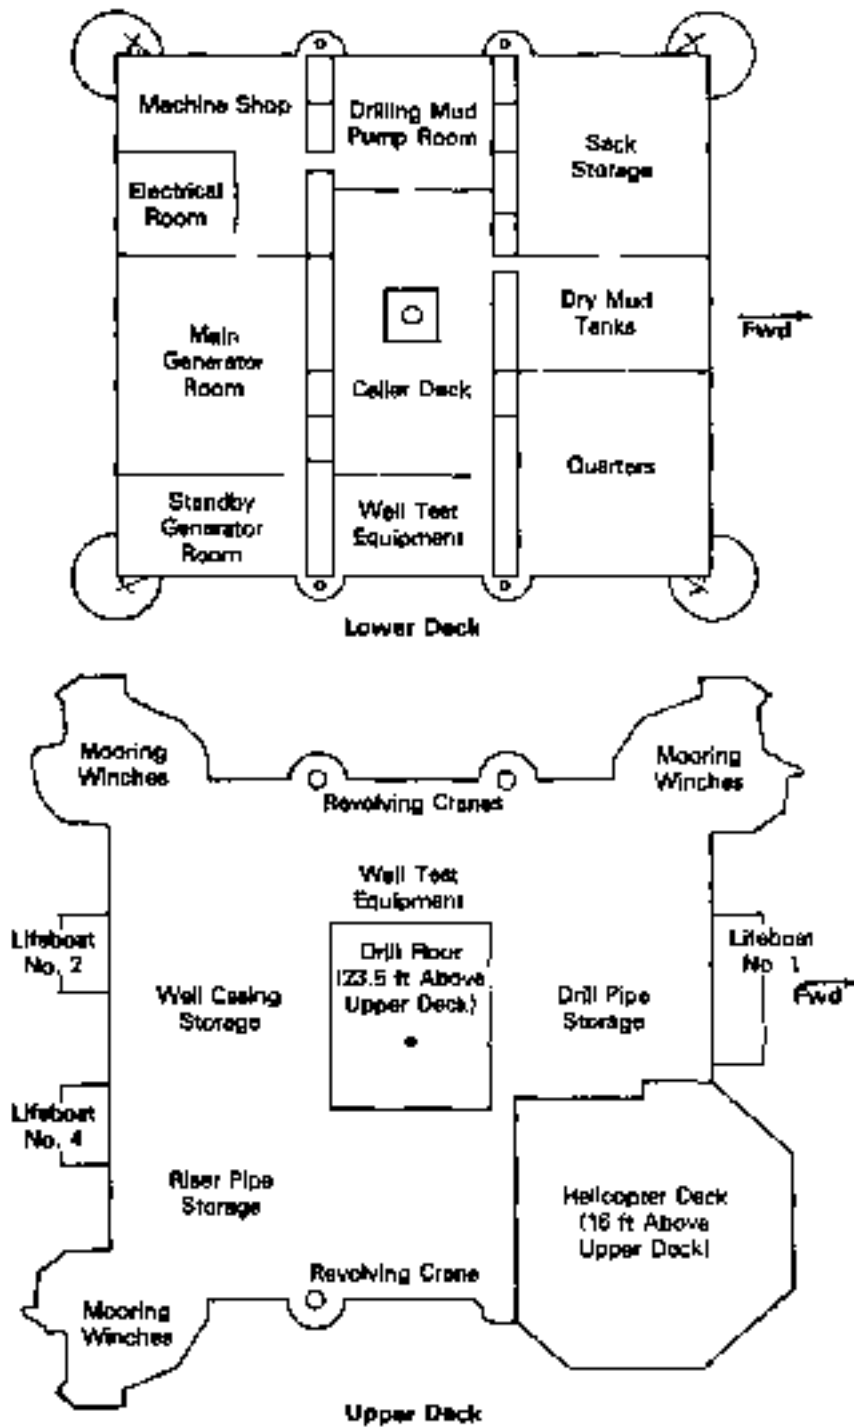
Figure 3.--Lower and upper deck arrangements.

The divers burned out one of the broken portlight frames (D on figure 3) from the ballast control room in the starboard column and entered the ballast control room through a 30-inch hole. Inside, they found the doors to the lower portion of the control panel open. The manual brass actuating rods were inserted in many of the valve control solenoids for the individual tank valves in both the port and starboard hulls. All but one of the solenoids with the rods inserted was found in the activated position. All 64 solenoid valves, together with the switch panels and the mimic boards, were removed. A

The underwater video tapes taken in March 1982 and the July 1982 diving survey both show two broken portlights. One portlight was behind the tank gauges (portlight D, figure 3) and the other one was the after portlight on the portside near the front of the ballast control console (portlight C, figure 3). With the OCEAN RANGER on a heading of 311°, the forward broken portlight would have been facing in the direction of about 245°, and the after portlight would have been facing in the direction of about 175°. The weather observer aboard the OCEAN RANGER reported that the wind and waves shifted from 220° to 270° between 1730 and 2330 on February 14. From the radio communications and the intercepted transmissions, it was not possible to determine whether both portlights or only one portlight broke around 1900, nor was it possible to determine from the intercepted transmissions whether the second portlight broke between 2100 and 2200. However, the intercepted transmissions indicated that the crew of the OCEAN RANGER was experiencing some problems with the control panel. If portlight C had broken between 1900 and 2200, water may have splashed on the ballast control panel and caused an electrical malfunction. Any water entering through portlight D would be partially deflected by the gauge panel and should not have immediately affected the control console. The cause of the breaking of the portlights could not be determined specifically; it may have been caused by hydrostatic pressure, debris or ice in the water, or hoses or lines swinging in the wind. The Safety Board believes that the USCG should evaluate the adequacy of existing standards for portlight installations in those ballast control rooms located in columns of semisubmersible MODU's.

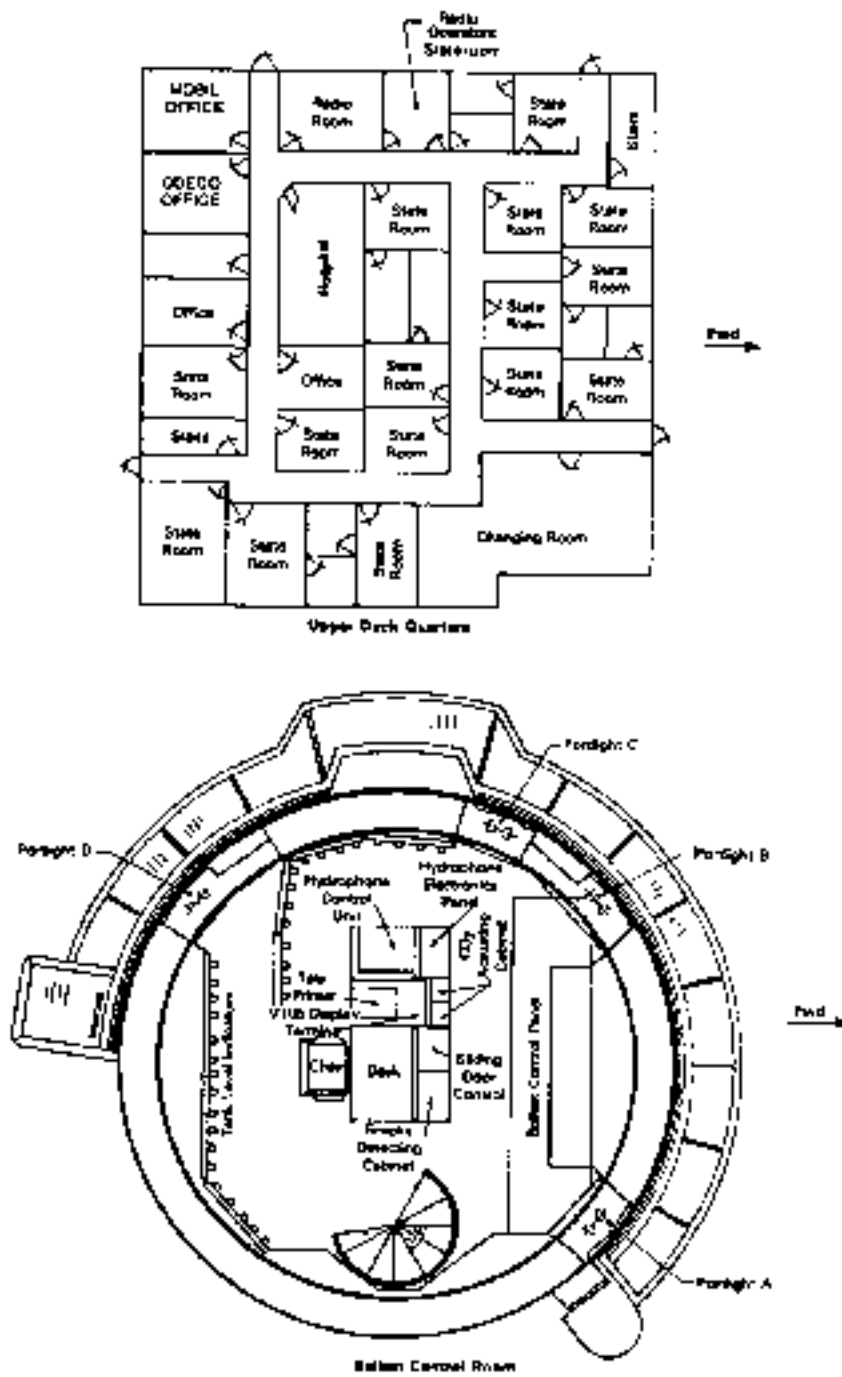
Figure 4.--Upper deck quarters and ballast control room arrangements.

The ballast control room contained the ballast control panel in the forward end of the circular room. One portlight was located on each side of the control panel (see A and B on figure 4); one portlight was located aft of portlight B (see C on figure 4); and one portlight was located in the after end of the control room behind the tank level indicators (see D on figure 4). The portlights were of standard marine design with tempered glass and metal deadlights with securing devices. The port tank level indicators were located on the starboard side of the control room, and the starboard tank level indicators were located on the portside. Two "bubble" type inclinometers were mounted in the control room—one in a fore and aft direction for observing trim, and the other one in an athwartship direction for observing heel. Each inclinometer had two spirit tubes—one with graduations from 0° to 5° and the other one with graduations from 0° to 15°. A similarly mounted pair of inclinometers also were located in the ODECO office. A desk was located in the center of the room with two VHF radiotelephones, sound-powered telephones, and a video display unit with roll, pitch, heave, wind, and wave information. A hydrophone control unit, a carbon dioxide (CO₂) actuating cabinet, a smoke detecting cabinet, and an H₂S gas detecting unit were also located in the center of the room. Access to the control room was gained by a circular ladder within the column from the lower deck of the upper hull. On the outside of the column, a vertical ladder was enclosed in a cage leading down from the upper hull to a walkway that extended two-thirds of the distance around the column at the control room level outside all four portlights. A handrail on the column extended around the outside of the portlights, slightly below their centers.

From February 18 to March 2, 1982, a side scan sonar survey was conducted of the wreckage of the OCEAN RANGER. The survey showed the drilling unit resting on the bottom in an inverted position about 500 feet southeast of the wellhead and drill pipe and other debris scattered 900 feet from the sunken drilling unit in a northwest to southeast direction. (See figure 6.) The derrick is located about 200 feet northwest of the OCEAN RANGER. The survey indicated that anchor cables in the fore and aft direction had parted while at least one transverse anchor cable to each corner column remained intact. A videotape survey conducted in early March 1982 did not indicate any structural damage to the hull, except minor damage to the bows of both lower hulls and two broken portlights in the control room. The portlight behind the tank gauges (portlight D, figure 4) and the next portlight near the portside of the control console (portlight C, figure 4) were broken. The deadlights on all control room portlights were found closed.

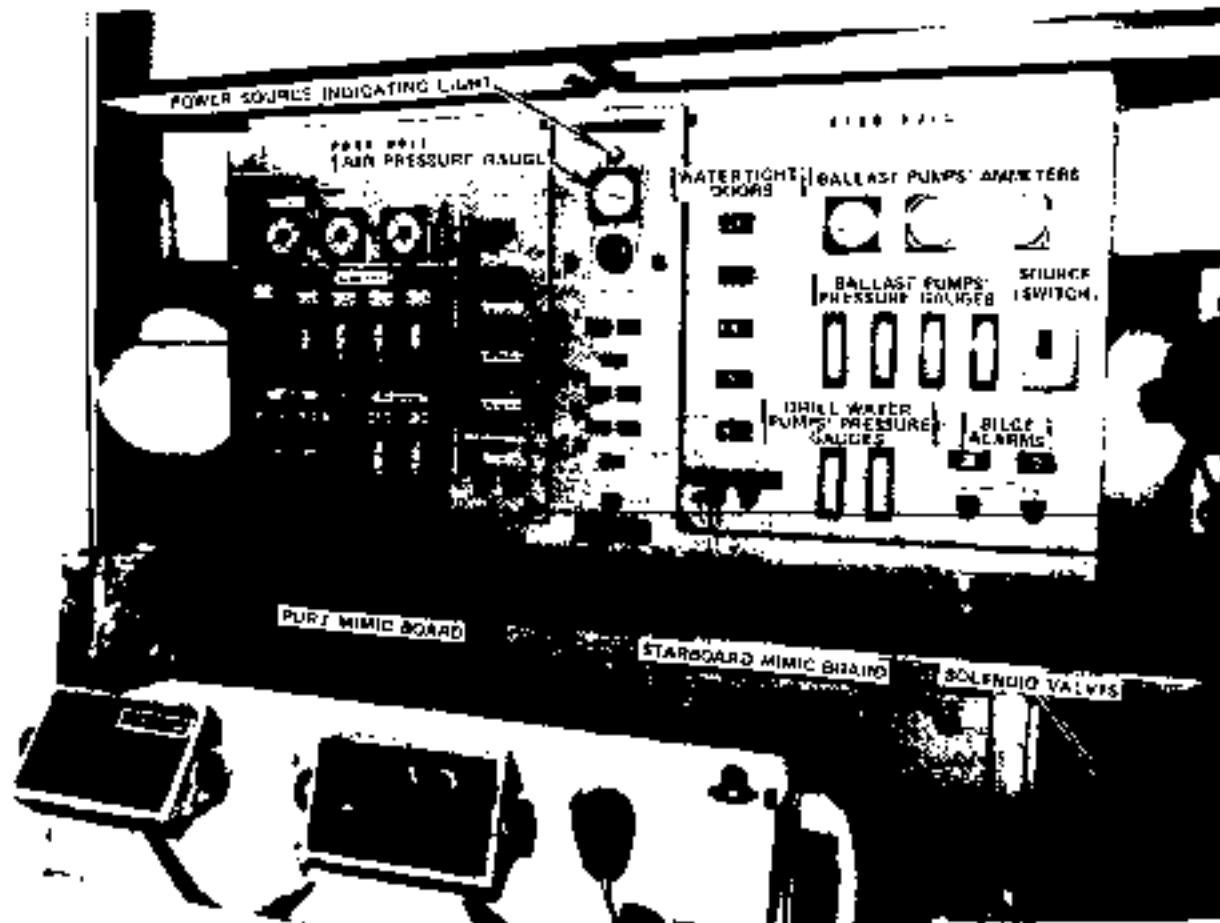
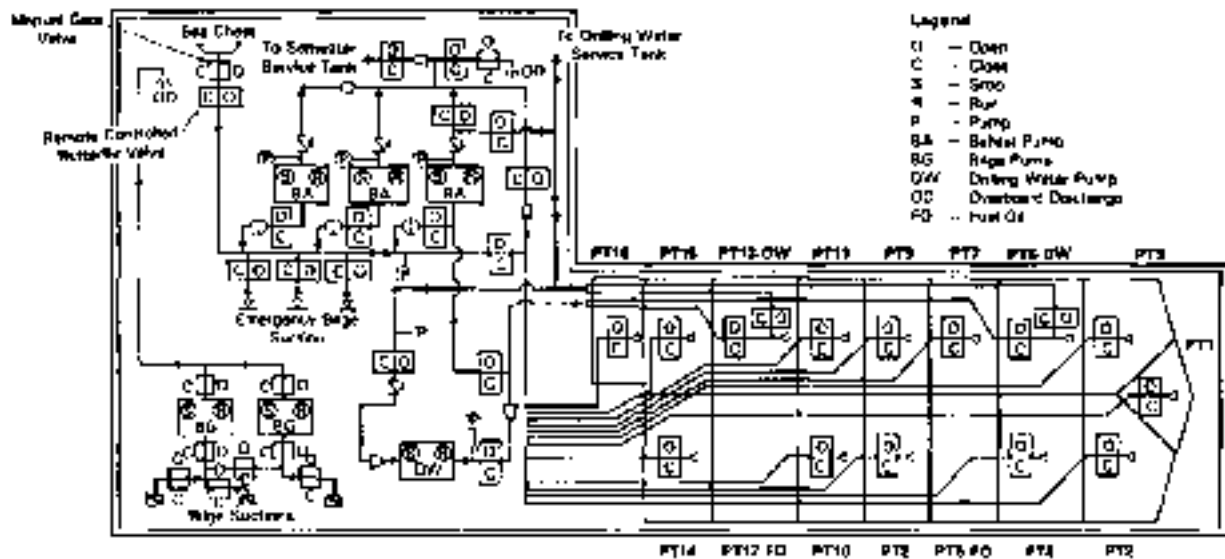
Figure 5.—Ballast control console and details of port mimic board.

The ballast control panel in the control room was designed especially for the OCEAN RANGER. A mimic board with the tank configuration and pipeline flow diagram of both the port and starboard hulls showed the operator the relationship of the tanks, piping, and corresponding valve control switches. (See figure 5.) Although the valves to the ballast and drill water tanks actually were located in the pumproom, control switches were mounted in the tank diagram of the mimic board panel. Each side of the panel was equipped with 32 pairs of valve control switches that operated the valves for 16 ballast and drill water tanks, 3 ballast pump suction valves, 1 drill water pump suction valve, 1 ballast pump discharge valve to the saltwater service tank, 1 ballast pump discharge valve to overboard, 1 ballast pump discharge valve to the tank manifold, 3 emergency bilge suction valves, 1 suction and discharge valve to the drill water pump, 1 suction valve to 1 ballast water pump for the drill water system, 1 discharge valve from 1 ballast water pump to the drill water system, 1 stop valve between the tank manifold and the 3 ballast pump suction valves, and 1 remote controlled sea chest valve. When depressed, each "open" switch activated a holding relay which, in turn, closed the circuit for the corresponding solenoid valve in the cabinet and opened the circuit for the indicating lamp in the red "close" switch. The solenoid valve admitted compressed air to the tubing connected to the valve operating gear in the pumprooms. The holding relay maintained power to the solenoid valve until the "close" button was depressed on the panel, thereby breaking the circuit at the holding relay, allowing the solenoid valve to return to the closed position, and venting the compressed air to the valve operating gear in the pumproom. The spring-loaded valve operating gear then closed the valve. The air was exhausted inside the control panel, providing the operator with an audible indication of valve closure. The spring-driven method of valve closing provided an automatic safeguard when control air was lost for any reason. If electrical power to the control console was lost, the solenoid valves could be controlled manually by inserting a brass actuating rod into each solenoid. These brass rods were threaded into the end of the solenoid housing through a brass bushing. After contacting the solenoid within the housing, the rods could then be further threaded in to override the solenoid spring. The compressed air would be then admitted to the line connecting the solenoid valve to the valve operating gear in the pumproom. Upon releasing the brass rod, the solenoid would return to its normal position, allowing the air to escape and the valve to close.

preliminary examination revealed a broken lead-in wire on the P-32 switch for the remote controlled port sea chest valve and an "x" was marked on the top of the panel to the switch. The P-19 switch for the drill water discharge valve was burned at the base of the switch around the wires on the closed side of the switch. An "x" was marked next to it on the panel. The P-27 switch for the stop valve in the ballast discharge line to the port ballast tank manifold also had an "x" marked next to it on the panel. The clear plastic covers to the three starboard ballast pump control switches, two port ballast pump control switches, and both the port and starboard drill water pump switches were missing. The frame of the second broken portlight (C on figure 3) was unbolted and brought up. It was noted that all glass fragments had been removed from around its edge. Various documents were also removed and preserved.
